DEPARTMENT OF TRANSPORTATION

Contract #: 04-0120F4Cty: SF/ALA Rte: 80 PM: 13.2/13.9File #: 69.28**WELDING INSPECTION REPORT****Resident Engineer:** Pursell, Gary**Address:** 333 Burma Road**City:** Oakland, CA 94607**Report No:** WIR-001497**Date Inspected:** 29-Jan-2008**Project Name:** SAS Superstructure**OSM Arrival Time:** 700**Prime Contractor:** American Bridge/Fluor Enterprises, a JV**OSM Departure Time:** 1430**Contractor:** Zhenhua Port Machinery Company, Ltd (ZPMC), Changxing Island **Location:** Shanghai, China

Bridge No: 34-0006**Component:** Tower Mock-ups and OBG**Summary of Items Observed:**

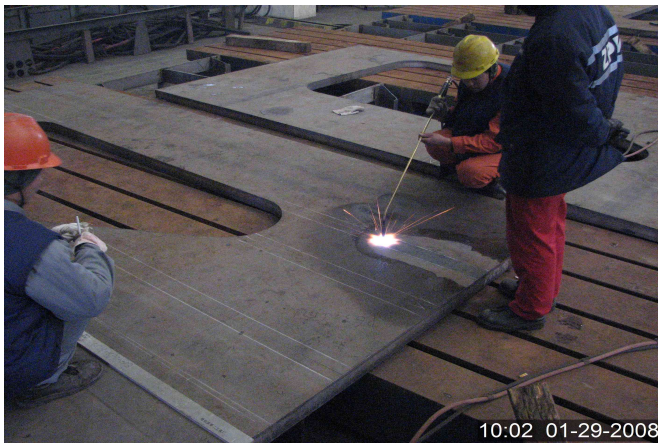
The Quality Assurance Inspector witnessed ZPMC performing heat straightening operations to Diaphragm plate P632. Quality Control relayed the heat straightening was being performed in accordance with HSR1(T)-030.

Below is a digital photograph illustrating the heat straightening in progress.
